Analysis of a Externally Modified Combustion Engine to Operate with a Immiscible Fuel of 80% Gasoline and 20% Water

Melchor Llosa Demartini^{*1}, Juan Carlos Cuba Solano²

Science Department, UTEC University; Av. Cascanueces 2221 Santa Anita. Lima – Perú

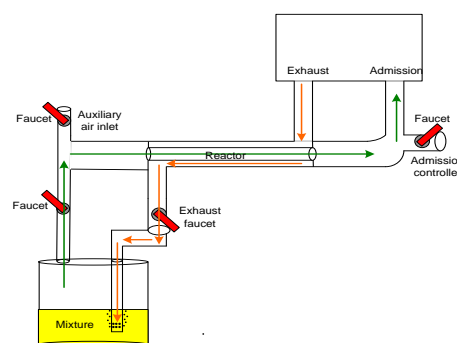
We started by making changes in the combustion engine of a motorbike to work with immiscible fuel 80% water and 20% gasoline. For example, we made the modification described below, which consists in the construction of two independent circuits for the intake (green) and exhaust (orange).

This circuit corresponds to a Pantone engine, where the carburetor has been removed in our modification. See figure 1.

FIGURE 1 SCHEME MODIFIED ENGINE.

With this scheme hydrogen is obtained by hydrocarbon reforming reaction. Generic hydrocarbon-reforming reactions are

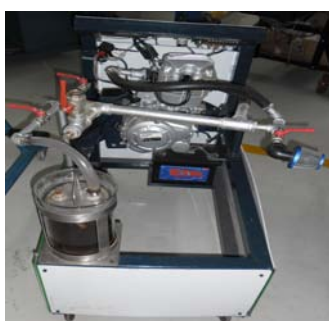
The measurements were made with traditional fuel under stationary conditions and then the measurements were repeated again with the arrangement described above. Figure 2 shows the experimental setup. In this way we can have a quantitative comparison with respect to conventional fuel.

FIGURE 2 EXPERIMENTAL SETUP.

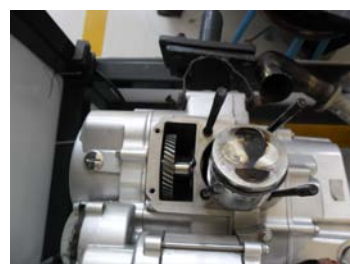
To perform our component analysis the engine was disassembled into components, as can be seen in Figure 3, using a set of previously calibrated measuring instruments.

FIGURE 3 EQUIPMENT DISASSEMBLY.

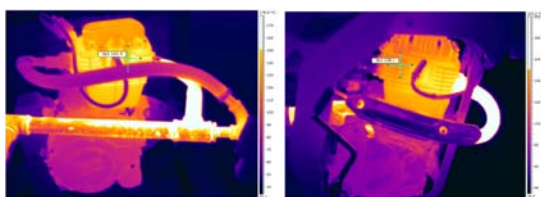
In zone 1 corresponding to Figure 4 we observe a variation of 2,46%, in zone 2 of Figure 5 we observe a variation of 0% and in zone 3 corresponding to figure 6 we observe a variation 0,36%, which are minor variations.

FIGURE 4 MODIFIED AND STANDARD MOTOR TEST 1.

We should mention that pictures shown in figures 4 thru 6 were obtained under normal operation temperature.

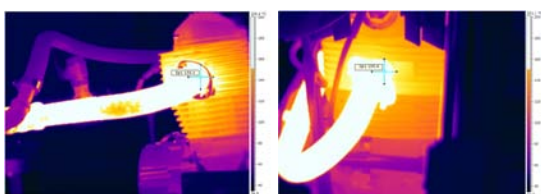
FIGURE 5 MODIFIED AND STANDARD MOTOR TEST 2.

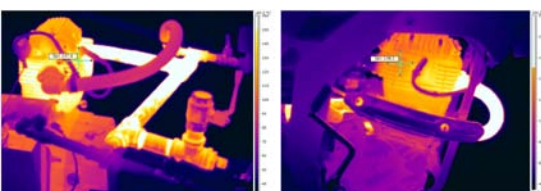
FIGURE 6 MODIFIED AND STANDARD MOTOR TEST 3.

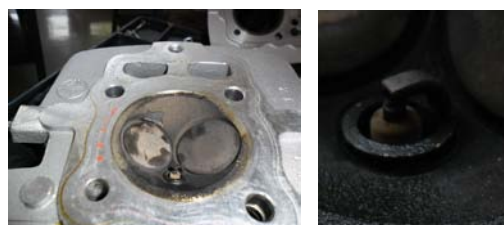
In Figure 7, we observe the the state of a combustion chamber, where no apparent damage, cracks or crevices can be seen. What one can see is a proper charred and the absence of rust, which is a prrof that water has not been present in the combustion chamber, nor oil, given us an advance indication of the state of pistons and rings.

What we can observe is an excellent carbonization, which is a proof of an almost complete combustion of the fuel used.

Figure 7 shows a close-up of spark plug where we can also notice a good char and the absence of oxide which gives optimum performance, as this item need carbonization to perform better.

FIGURE 7 COMBUSTION CHAMBER AND PLUG.

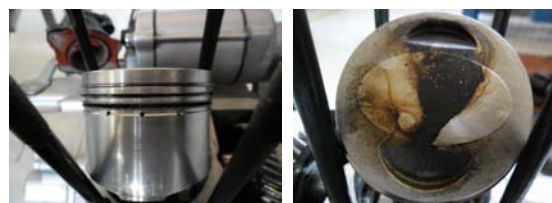
In Figure 8 we appreciate the appearance of the piston, not finding an indication at first glance of damage, burrs or something that makes us suspect an inappropriate malfunctioning. we removed the rings and measure the tolerances of these and the piston.

According to the manufacturer the clearance between the piston and cylinder is 0,02 mm with a limit of 0,1 mm, our measurement is 0,03 mm which is maintained within tolerance.

The distance between ends of the piston rings installed is between 0,10 to 0,25 mm with a maximum of 0,25 mm , we have found they are in the 0,12 mm therefore they remain within the tolerance range.

FIGURE 8 PISTON AND PISTON HEAD.

In Figure 8 we appreciate the piston head and did not see any structural damage, fatigue or deformation,

which we appreciated is adequate carbonization correct sign and fuel burning.
